RE: Lisboa Fish Hatchery NMDG&F; Minor Industrial; NPDES Compliance Evaluation Inspection; SIC 0921; NPDES NM0030121; May 1, 2019

NPDES Compliance Inspection Report

NMDGF Lisboa Springs State Trout Hatchery Compliance Evaluation Inspection NPDES Permit No. NM0030121 May 1, 2019

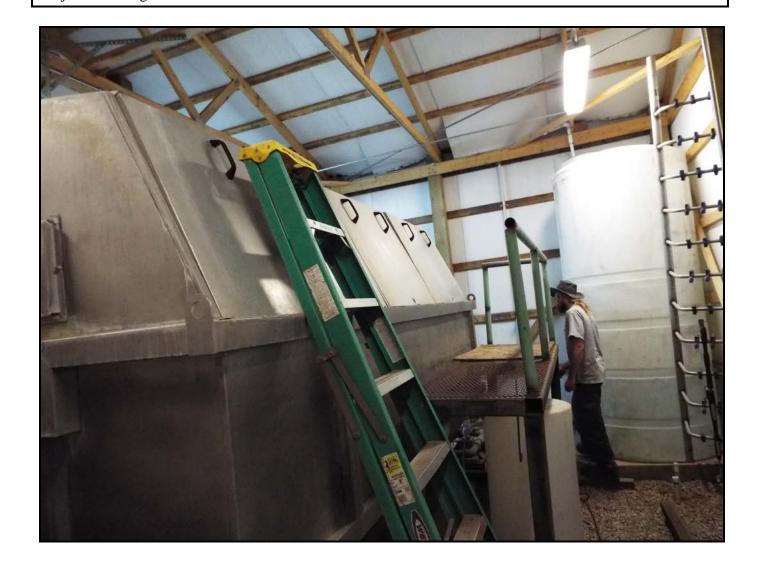
Photo # 1

Photographer: Daniel Valenta	Date: 5/1/2019	Time: 1106 hours					
City/County: 2.5 miles north of Los Vegas on Hwy 63/ San Miguel County							
Location: 26 Fish Hatchery Road, Pecos, NM							
Subject: Centrifuge filter to clean and reuse water.

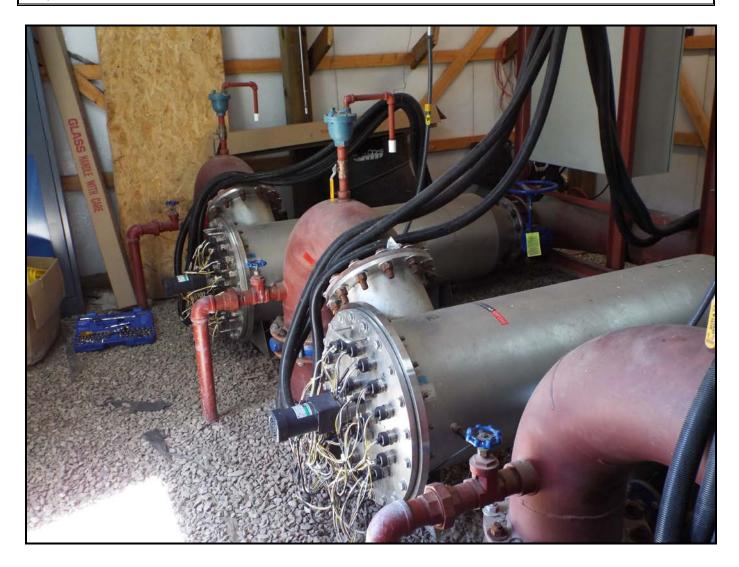
Photo # 2

Photographer: Daniel Valenta	Date: 5/1/2019	Time: 1113 hours					
City/County: 2.5 miles north of Los Vegas on Hwy 63/ San Miguel County							
Location: 26 Fish Hatchery Road, Pecos, NM							
Subject: UV chambers to clean and reuse water.

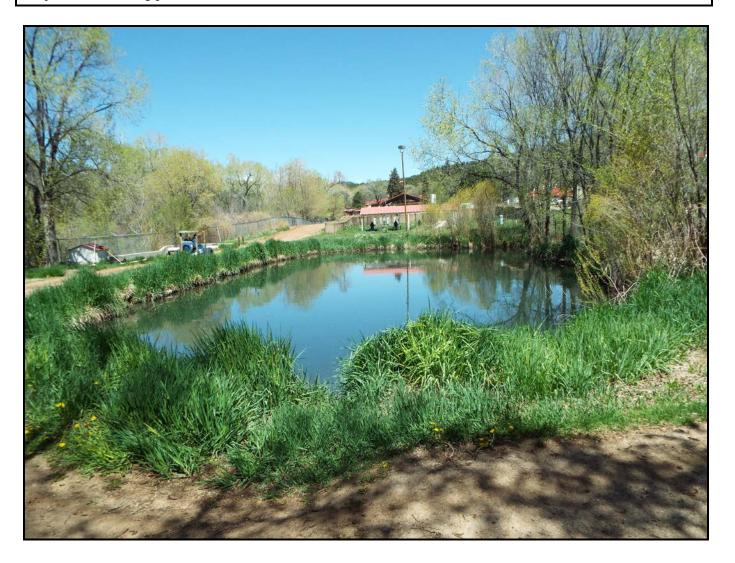
Photo #3

Subject: Final settling pond.

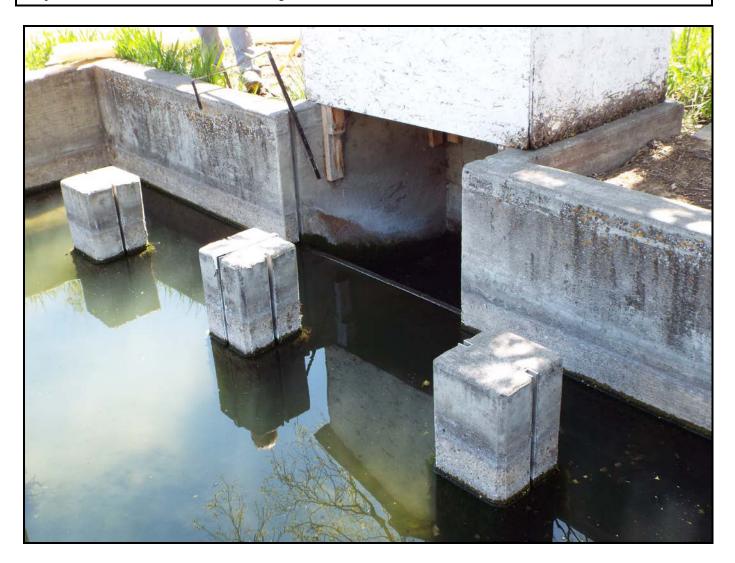
Photo #4

Subject: Flow is measured here and discharges to the Pecos River.
